Location	Fort Alice, Sri Aman	Ref No.	SA/WS/AR012
Subject	Site Visit with Local Teachers and Schoolchildren on the 17 th November 2014	Date	17 th November 2014
		Time	2.30-4.30pm
Attended by	Ref attached attendance list	Conducted by	Mike Boon
Recorded by	Dennyse Boon (13 years old) & Daryl Boon (11years old), edited by Teo Hui Kun (mother)	Coordinated by	Goh Kaw Sze

Follow-up site visit to Fort Alice before completion

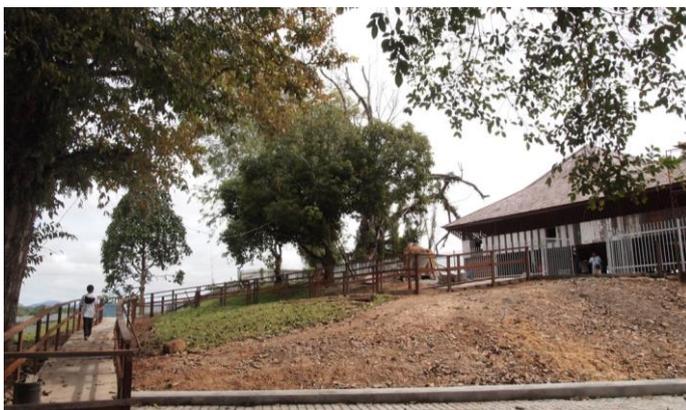
View of the nearly completed fort from the landing leading to the fort through a new pathway.

We gathered at the foot of the hill at 2.30pm where we were treated to a complete view of the Fort with newly installed pathway and fencing. The new pathway started at the landing between the entrance gate and the fort on top of the hill. This pathway was built to enable disabled persons to have an easier way to reach the fort. It was built with cement floor finish with wooden handrail, about 12-metres long and spiralling up the slope. The turning point has a beautiful panoramic view of the river complemented by the big tree on the slope. We could imagine seeing the *benak* (tidal bore) coming from the river mouth, which will surely conjure a lovely image. As one walked further, the fort came in view. At the end of the pathway is the entrance to the fort with cement pavements. The pavements also served as external drains with gaps in between to channel rainwater runoff.

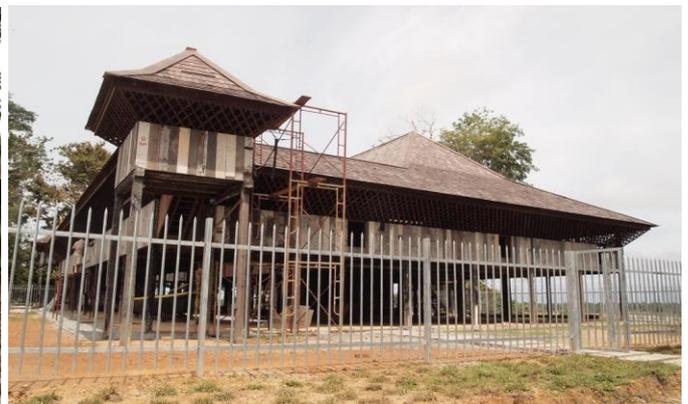
Newly installed steel fence around the fort.

There was a new metal fence being built about five-meters away from the fort. Mr Mike told us that according to the historical photos of the fort taken in 1875, there were short, pointy wooden fences surrounding the fort. They were built short so the sentry guards would be able to see any incoming enemies. To replicate this, a 6-foot tall fence was built with pointed-end steel rods. Steel was chosen to differentiate it being a new addition to the heritage building. Building the new fence near the building also allow visitors to see the conserved fort up-close, when the heritage museum (inside the fort) is shut or after opening hours.

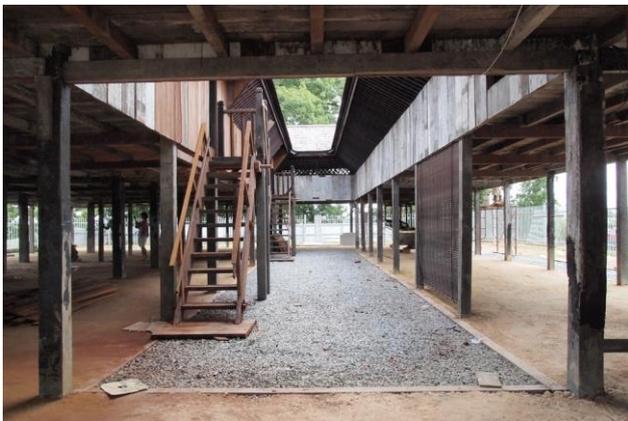
Courtyard functioning as ventilator to keep the fort cool.

After that, we were brought inside to the courtyard of the fort. The courtyard was unique to this fort as no other Brookes' forts were built with a courtyard. The courtyard created a tunnel effect where hot air from ground floor was drawn away. It was indeed very cooling standing in front of the courtyard.

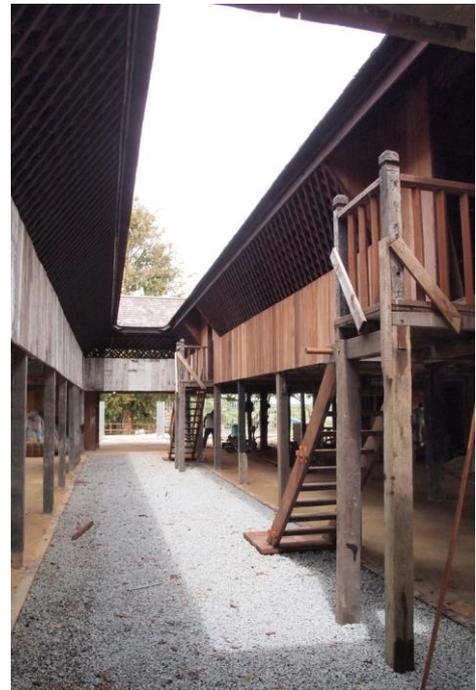
Side view of the drawn-up staircases.

The staircase can be lifted when the 'shaft' rotates.

We then proceeded to look at staircases in the courtyard. They were amazingly built without modern nails and were movable without the steps falling apart. Mr Mike said that ideally, the staircases are able to be drawn up, but they are too heavy to be lifted because of the weight of belian wood used to construct them. This design was also seen in old photo of Fort Sylvia in Kapit, which has similar drawn-up staircase.

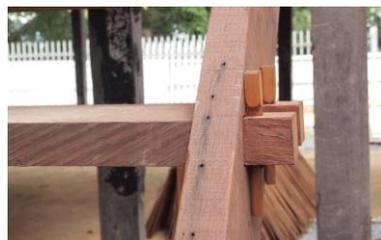
Steps are held together with wooden pegs.

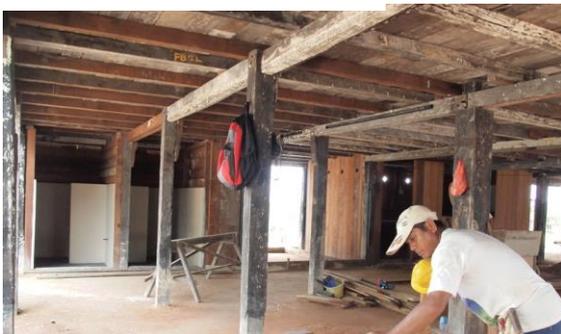
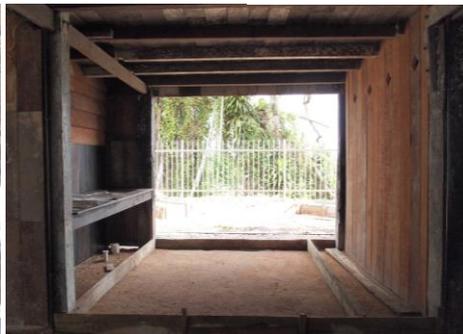
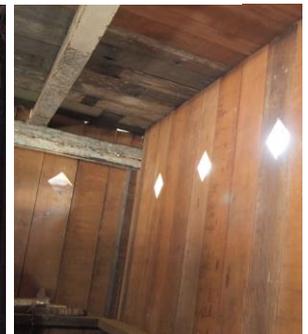
Ground floor rooms under construction. Toilets (L); pantry (M) & interior of the security room (R).

Three rooms came to view as we explored around the ground floor. The biggest room was the security room with wall panels built to make the room looked like a lock-up cell. In the 60's, the ground floor was used as a jail. The other rooms were the toilets and a pantry. The pantry cabinet was made of left-over timber from construction.

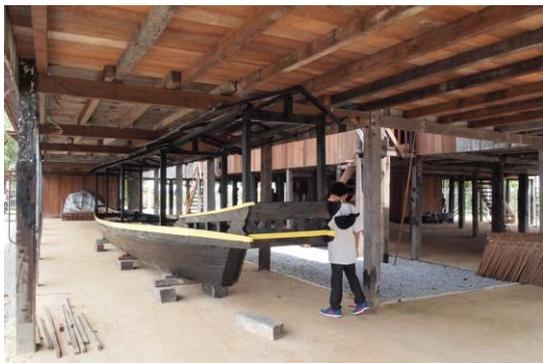
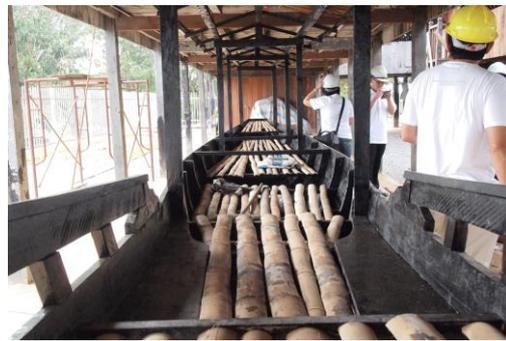
A 34ft long Iban warboat being constructed. Imagine it when it was carrying many warriors!

There was a wooden boat being built at ground floor besides the courtyard. It was a replica of an Iban war boat, 34ft long and could fit in many warriors. It would have a thatched roof when completed. According to the carpenter, the whole boat is detachable and could be re-built like ‘Lego’ blocks. There will also be a Malay sampan and a Chinese trading boat to be built for display here. These signified the three communities who helped to build the original Fort Alice.

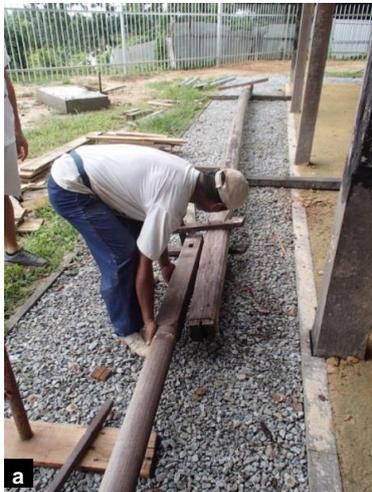
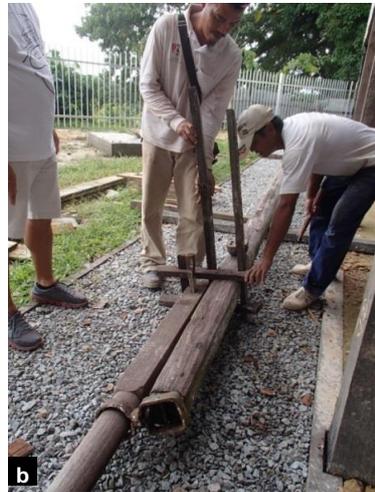
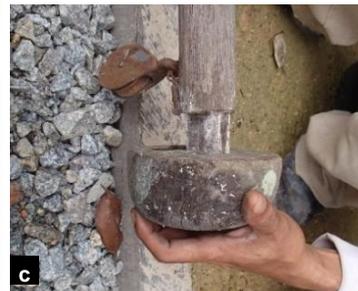
Flagpole re-assembling process. **a.** Upper pole was laid to the side of the lower pole. **b.** Fixing with timber and steel brackets. **c.** Upper pole was capped with a belian capping with a “built-in” pulley.

Three components of an old belian flagpole were seen lying on the ground during our visit. The Master Carpenter showed us the process of re-assembling the flag pole which when erected would be 42ft high. The square (bottom) and round (top) poles were held together by a metal ring made to suit the shapes of the posts. It appeared to look like the mast of a sailing boat.

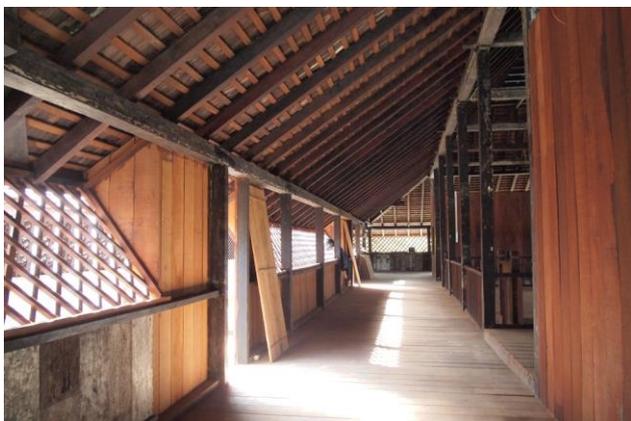
Entrance to the centre courtroom from the staircase in the courtyard.

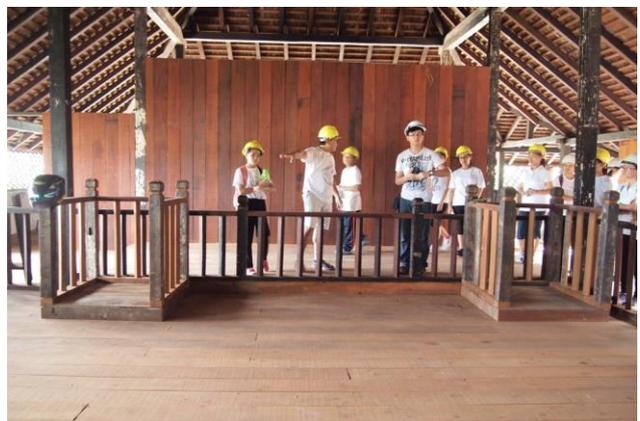
Timber balustrades installed in the courtroom, with a raised platform for the judge’s dais and two witness boxes.

We then proceeded to the courtroom in the centre of the upper floor. It had timber balustrades installed to mark the court area, with a raised platform for the judge’s dais and two witness boxes. Behind both sides of the court were rooms, the Rajah’s bedroom and two smaller rooms to be used for storage and AV room.

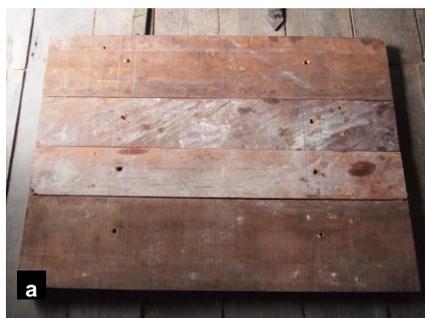
a. Pre-drilled holes on the timber door.

There were ten openings on first floor walls below the timber lattices to mark the placement of canons. The master carpenter explained the traditional technique used to make the timber door with ship nails; metal straps and hinges and showed us the way to fix the cannon doors onto the wall.

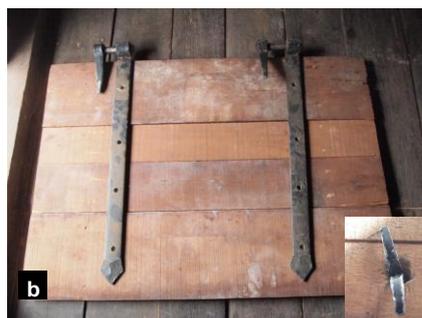
b. Metal strap laid onto cannon door with pre-drilled holes. Custom-made ship nails with split-ends were nailed through metal strap.

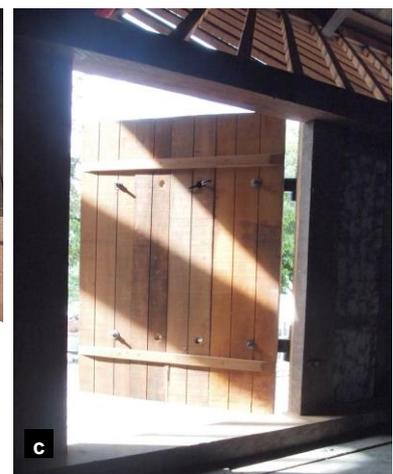
c. Metal hinges were slotted into fixed components on the door’s timber frame on the wall.
