Location	Fort Alice, Sri Aman	Ref No.	SA/WS/AR010
Subject	Site Visit to Fort Alice	Date	26.05.2014
		Time	2.30pm – 4.00 pm
Attended by	Refer to attached attendance list	Conducted by	Mike Boon
Recorded by	Mike Boon	Coordinated by	Nelly Soh

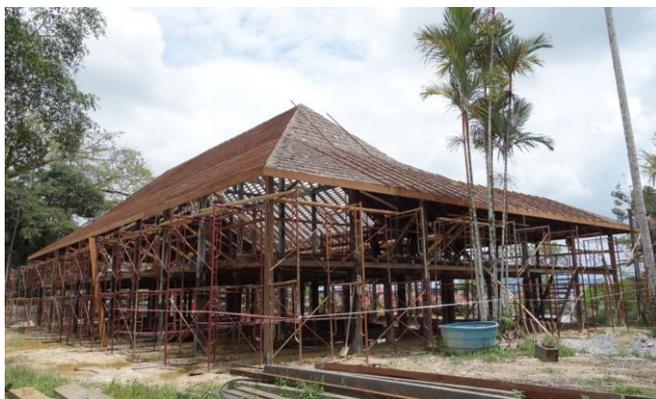
Fort Alice under reconstruction during last visit on 26.03.2014.

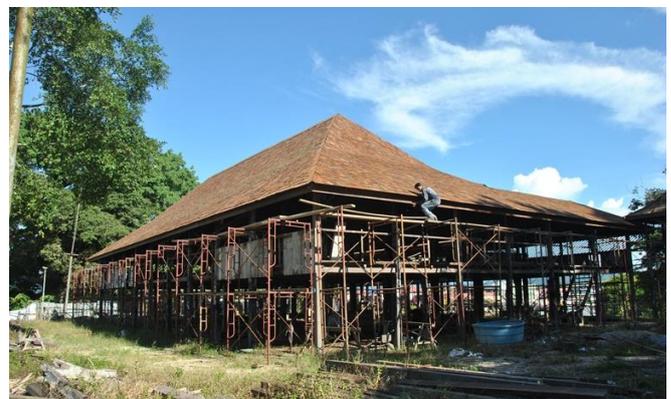
Roof and wall cladding works in progress on 26.05.2014. (Photo by Tan Ting Huat).

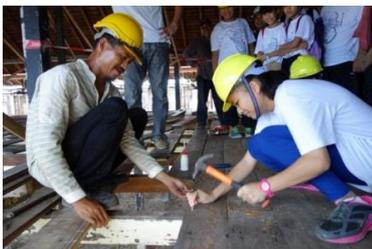
Learning the pegging skill guided by Master Johari.

Belian floor boards were pre-drilled at an angle to receive belian dowels at every floor joists. A few pieces of floor boards were clamped to position for belian dowel to be driven into the pre-drilled hole; the portion of dowel above floor board was trimmed with a 'V-cut'; trimmed portion was inserted back into the open 'V' end above the floor board, then hammer them in until refusal; then trim the dowel with a chisel to flush with the floor surface. The floor boards will be sanded down by hand to receive oil finish.

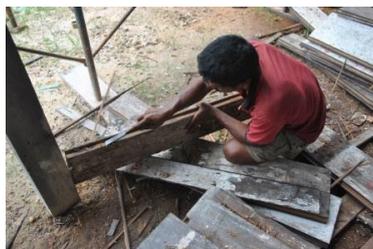
Old floor boards and wall panels were selected and processed for reuse.

Dismantled old floor boards and wall panels were checked for wet rot, insect infestation and split surfaces. Belian boards and panels were selected for reuse with nails carefully removed. Other timber species that are still in good condition were recycled for other usage later.

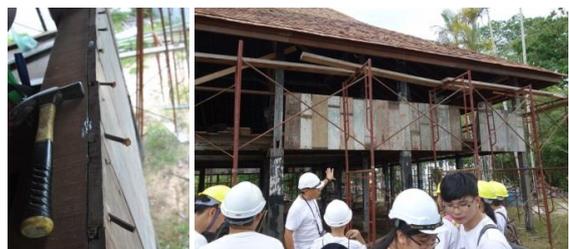
Wall panels with rebated laps are temporarily held in position with steel nails, which will be replaced with 'belian' dowels to secure the panels.

Similar method was used to install the wall panels. Wall panels were pre-drilled to receive square galvanised steel nails, in order to secure them temporarily to top and bottom rails in-between columns. Thicker panels were notched to achieve even surfaces of the wall. These panels were pegged in with belian dowels. The wall panels will be finished with lime-wash.

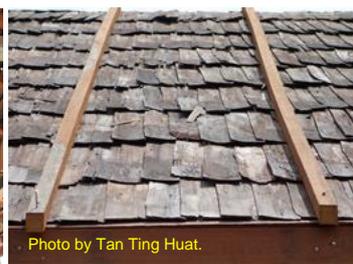
Belian shingles moved under different weather conditions. They warped when dry and levelled up when wet.

The instability of new machine-cut shingles under wet and dry environment was discussed in the last site visit on 26.03.2014. The participants were brought to see how layers of different materials were installed on the roof to solve leaking problem of belian shingle roof.

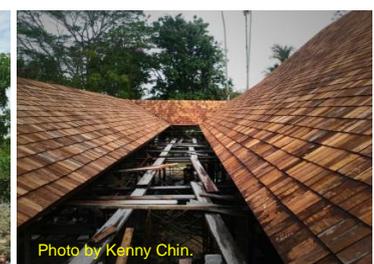
New machine-cut shingles are used for top finishing.

Layers of aluminium foil and 'Rockwool' insulation blanket were rolled over the old shingles to provide sound and heat insulation. A metal tray was then laid over to receive new belian shingles as top covering.

If the new belian shingles leaks, the metal tray will collect the water and drain off at roof eaves. This 'sandwich' detailing system constructs a roof that looks and feels like shingles from inside and outside!

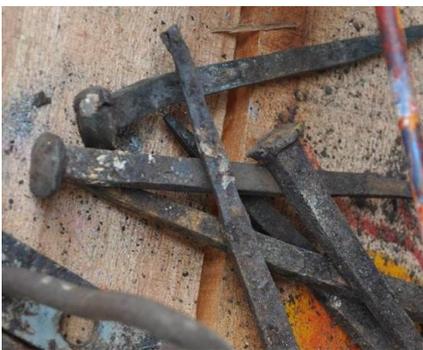
19<sup>th</sup> Century hand forged iron nails used in the old fort.

Old nails dcollected during dismantling of Fort Alice were identified as 19th Century hand forged iron nails by Professor Miles Lewis in Melbourne. John further explained that local made these nails that were as strong as their 'parang' in various sizes. They were only produced in small quantity because of scarcity of raw material and extensive labour to make them.

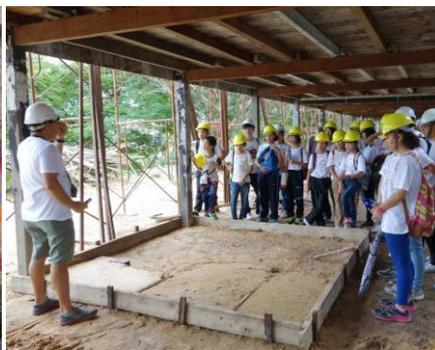
Samples of compacted clay floor prepared on site.

The project team intended to construct a earthen floor similar to the Hakka Gold Minner's Old 'Kongsi' House in Marup. The Contractor had prepared samples by mixing clay, sand and water of various ratios, with shredded fibreglass added to reduce shrinkage when dry. The mixtures were churned in a concrete mixer before spreading to the prepared ground. The 50mm thick spread was compacted and left to air dry.

The local Malay advised a more 'modern' technique by sprinkling cement just before the surface dry up. However the project team prefers to keep their fingers crossed and wait for the result. They are prepared to conduct more experiments to find the correct 'recipe', just like the experiments on the 'recipes' of lime-wash for application on belian wall panels.

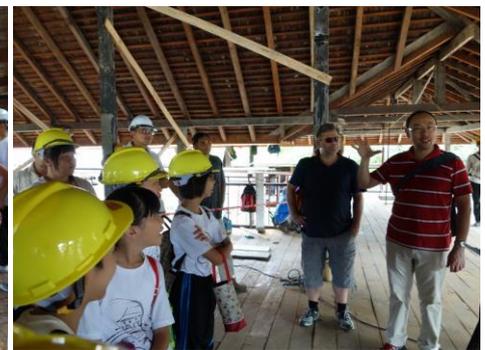
John Ting talked about how the interiors will be reconstructed.

John Ting gave a preview of how the interior of the fort will be re-constructed based on information he gathered from his research.

The Court Room surrounded by officers working desks; the Rajah Residence's living spaces and bedroom; and the additional rooms for their guests, will be re-constructed with dated furniture and artefacts. The interiors will be revealed gradually in future site visits.
