## Fort Alice given a new lease on life

Rising from the ashes, Fort Alice sits majestically on a small hill.

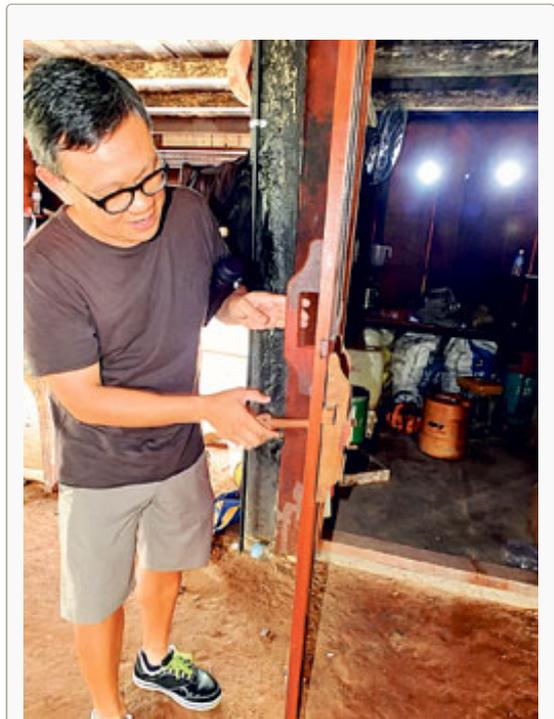
Boon shows how the locking mechanism works when the wooden key is inserted.

Fort Alice's uniqueness, which is hardly seen today, is the traditional wooden locking system brought back to life by 42-year-old Mohd Johari Kona, who learned it from his grandfather.

"To lock the door, a wooden key is inserted into a keyhole and twisted like a modern-day key and lock. I remember watching my grandfather making it and I observed how it was done very closely.

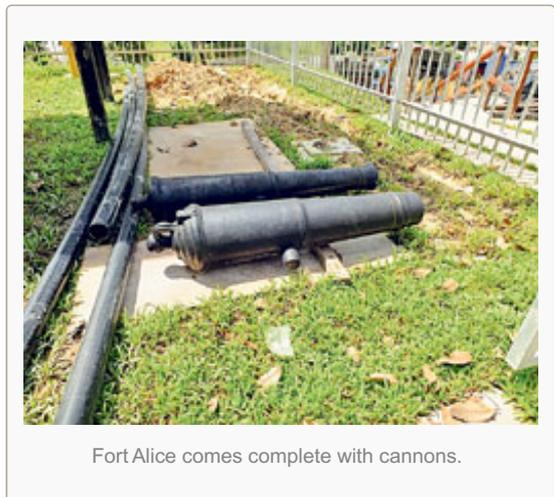
Fort Alice comes complete with cannons.

Small hinge-windows are located at the bottom of the walls for the cannons to protect the fort from attacks. Strangely enough though, even at the height of tribal warfare, the fort was never attacked.

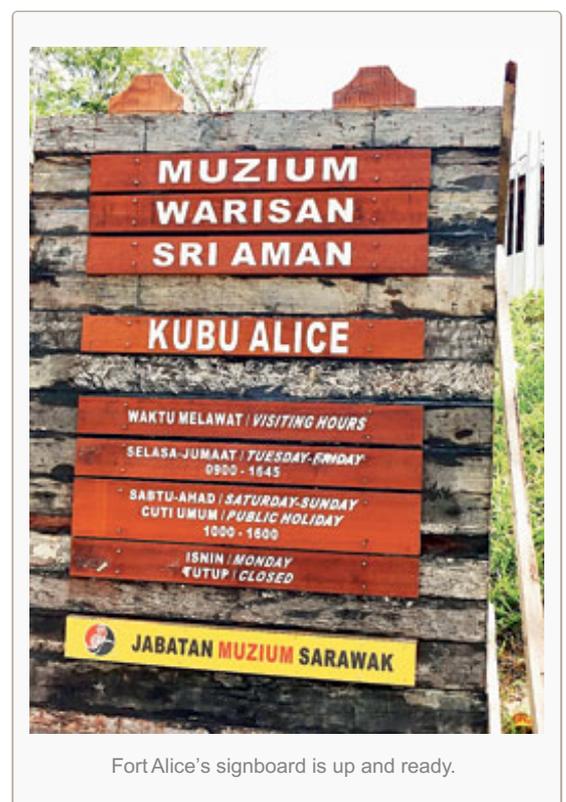
An 1875 photograph shows fencing of small wooden elements close to the building.

A photograph taken later in 1901 showed an outer layer of simple ranch-fencing extended to enclose the grounds of the Taman Panorama Benak for the grazing of livestock.

In support of the photographic evidence, fences of similar typologies and styles were also found in the other forts around Sarawak.
