## Conservation of the Square Tower

Text by Ian Parker. Photos by Lim Min Zhen.

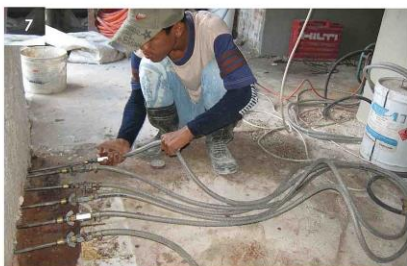
6. Removed plaster to a stable base.

The conservation works on the Square Tower's walls started with stripping the acrylic paint and damaged plaster back to a stable base to prepare for "desalination" of the wall. This was done using the "cocooning" method where pharmaceutical grade cellulose fibers in poultice form, soaked in distilled water, was applied to the walls and left there for 14 to 21 days where the salt content in the walls will be drawn out into the poultice.

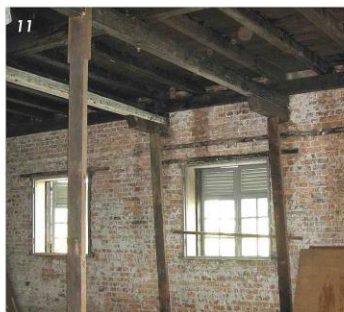
11. Timber bearers before restoration.

The ends of the belian joists and beams supporting the roof structure suffered wet rot where it was embedded into the damp wall. The rotted ends were cut off and a steel extension were introduced to carry the loading.

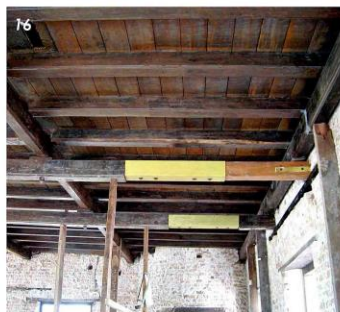
16. Timber bearers after restoration.

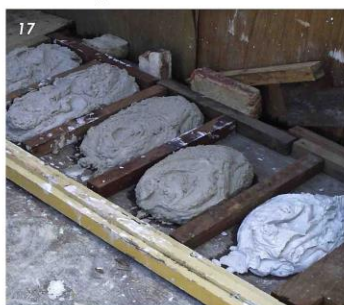
17. Trial mixes for the sand-lime plaster.

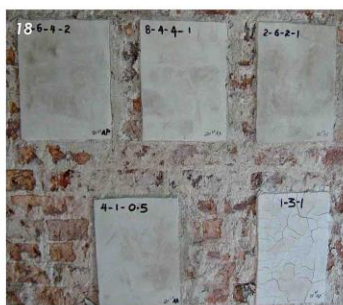
18. Test samples for plastering of various material compositions.

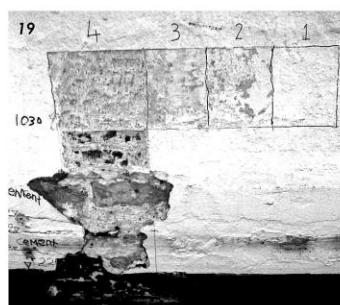
19. Removal of paint and plastering and paint in layers for investigation.
