Location	Fort Alice, Sri Aman	Ref No.	SA/WS/AR002
Subject	Site Visit with Local Teachers and Schoolchildren on the 17 <sup>th</sup> July 2013	Date	17 <sup>th</sup> July 2013
		Time	2.30-4.30pm
Attended by	Ref attached attendance list	Conducted by	Mike Boon
Recorded by	Geraldine Ho	Coordinated by	Goh Kaw Sze

**The Wooden Fort**

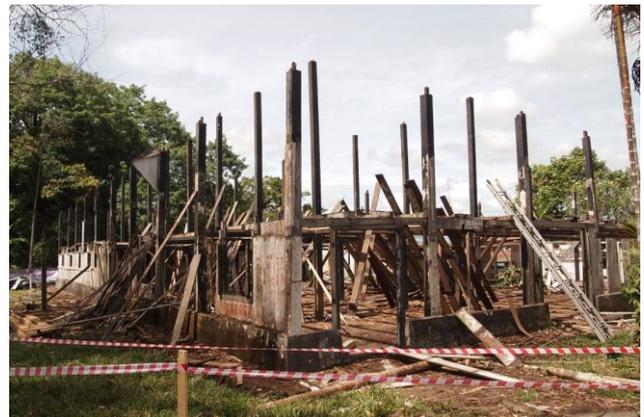
Fort Alice with her fabric in the process of being dismantled, recorded, and stored for reuse.

Bare to her wooden frame with paint peeling and various vegetation poking out from her many crevices, the Fort has definitely seen better days. There was also that all-pervading smell of must, which rather reminds one of unpleasant things that crawl in the dark which could preferably be avoided. I had also been told some workers had to chase out friendly neighbourhood snakes from one of her watchtowers during dismantling works. Rest assured though, I'm sure the organisers have made the proper arrangements to ensure every visitors' safety on site.

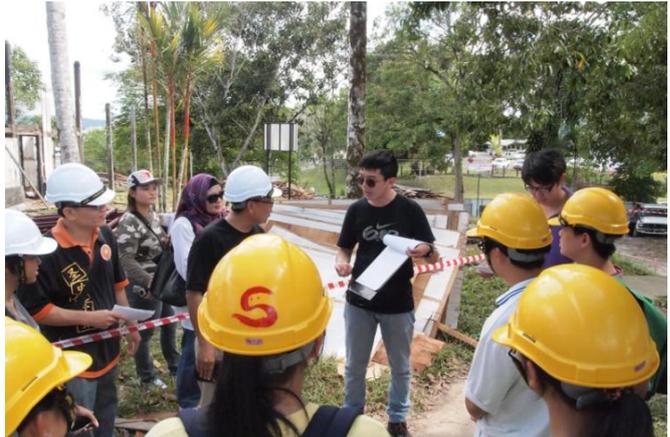
Conservator-on-Site Mr. Eng Chee Kuan showing his measured drawing records.

We were then given a brief induction into the Fort's dismantling process by Conservators-on-site Mr. Eng Chee Kuan and Mr. Ooi Zhen Ning (both young graduates from Penang). They explained that during dismantling, every detail has to be recorded through sketches, drawings, photographs and videos so the Fort can be reassembled in the same manner.

As the Fort is a timber structure, their key focus was on the traditional joineries used to hold the building together and we were shown many measured drawings of these. Interestingly enough, different joints were used to accommodate different parts of the building. They also pointed out how they had systematically coded every single piece of timber in different colours to coincide with their plan drawings so they would know where each would be put back in place.

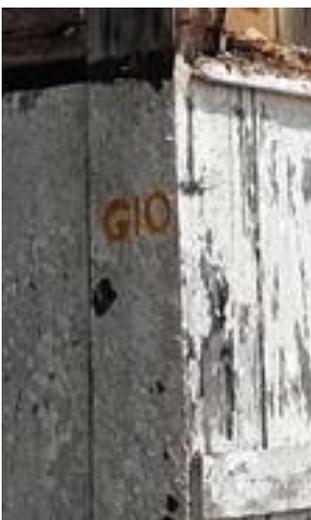
Colored codes on the timber pieces. (Yellow for main structural components, Red for secondary elements)

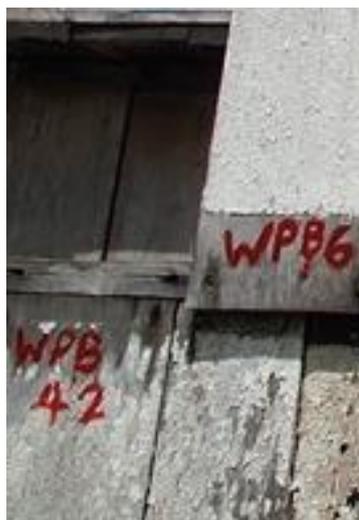
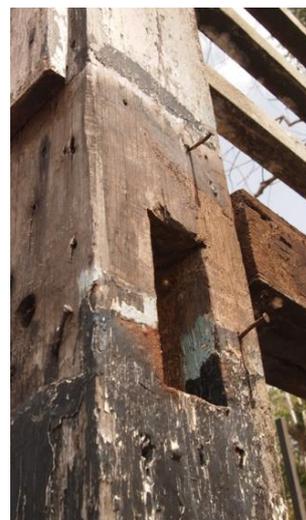
An example of a wooden mortise.

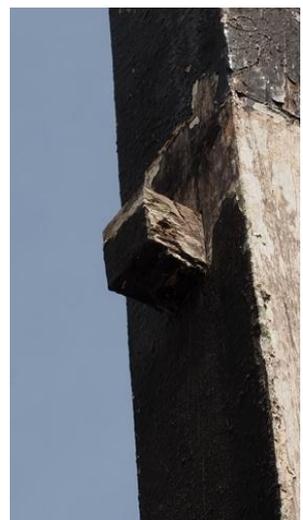
An example of wooden tenon.

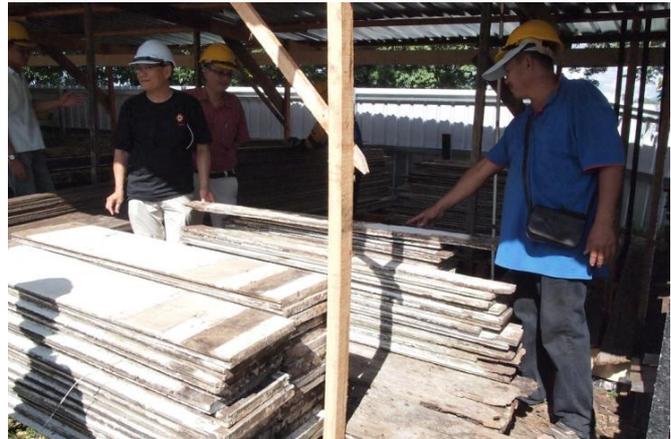
Ar. Mike Boon & Mr Ting Nik Sing demonstrating the techniques in differentiating different types of timber.

This was what we discovered from the simple exercise: Hear- belian produces a deeper tone when knocked as compared with hardwood; Touch- belian is denser than hardwood; Smell - belian has a very distinct smell from others; See- new timber planks have tongue and grooves mechanically cut into them. Old belian have adze marks on their surfaces.

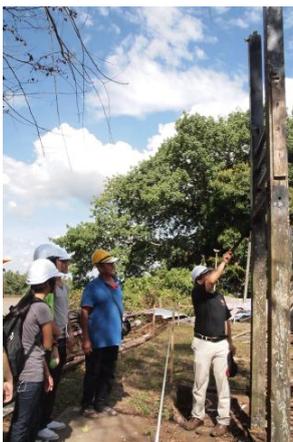
Pointing out joineries and explaining how they work.

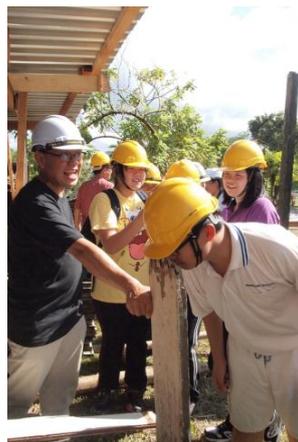
Smelling to identify the scent of belian.

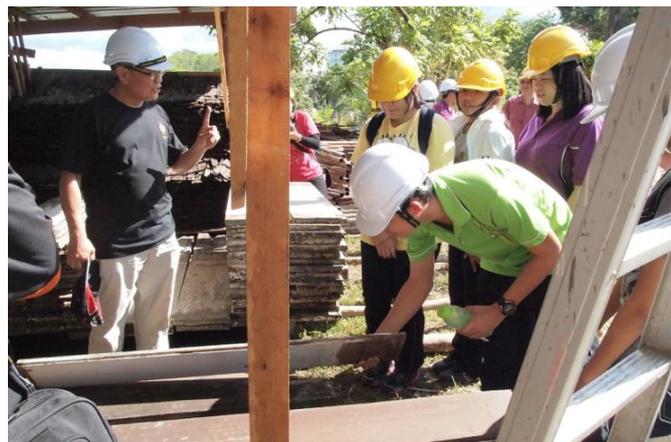
Lifting the timber to gauge the difference in weight between belian and other hardwood species.
